### Division of Oil, Gas & Mining

SUBJECT: Site Inspection, Staker Parson Companies, Lehi Quarry,  
M/049/031, Utah County, Utah

Date of Inspection: May 27, 2004  
Time of Inspection: 11:00 a.m.  
Conditions: Partly Sunny  
Participants: Mike Dalley, Staker Parson, Doug Jensen, Lynn Kunzler,  
DOGM

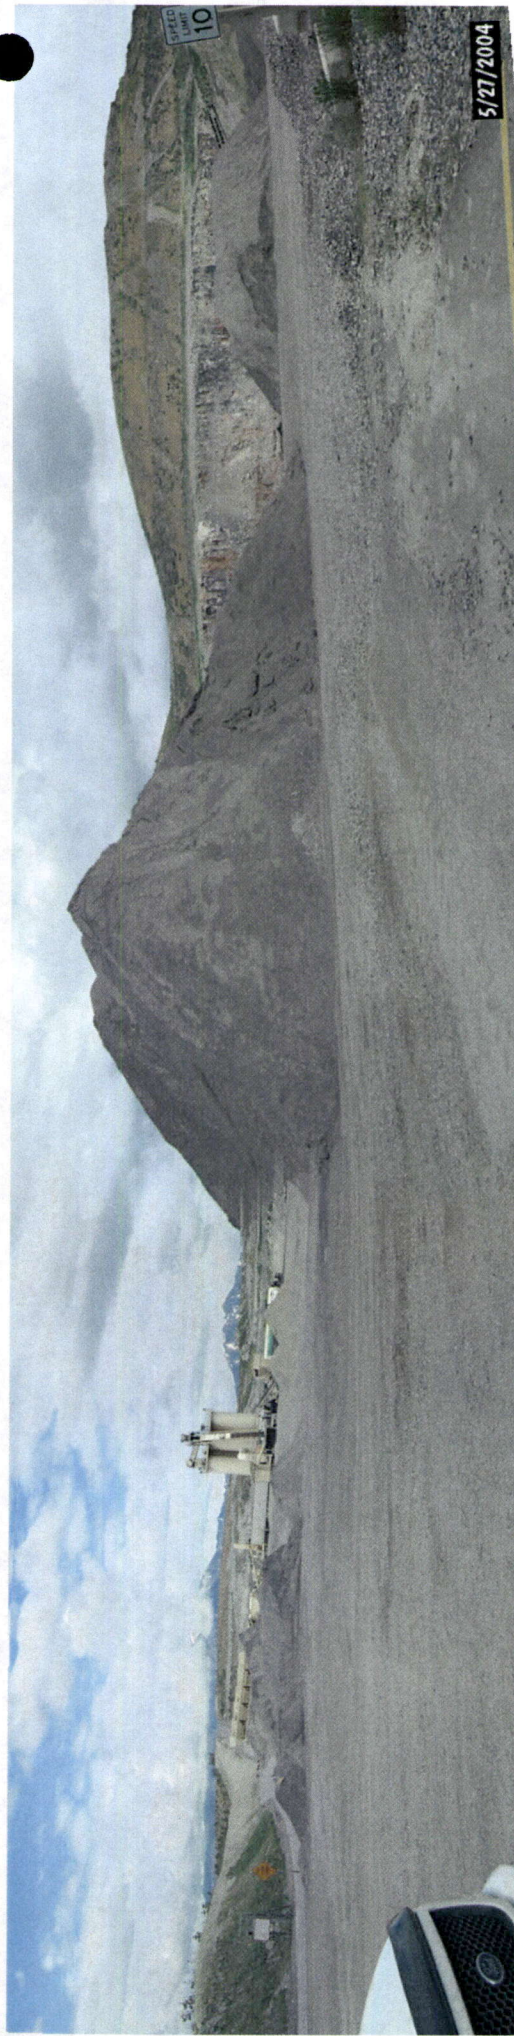
There is an asphalt plant (picture included in this report) located on-site which Mike indicated is for sale. This plant is to be sold and removed from the site.

ASPHALT PLANT

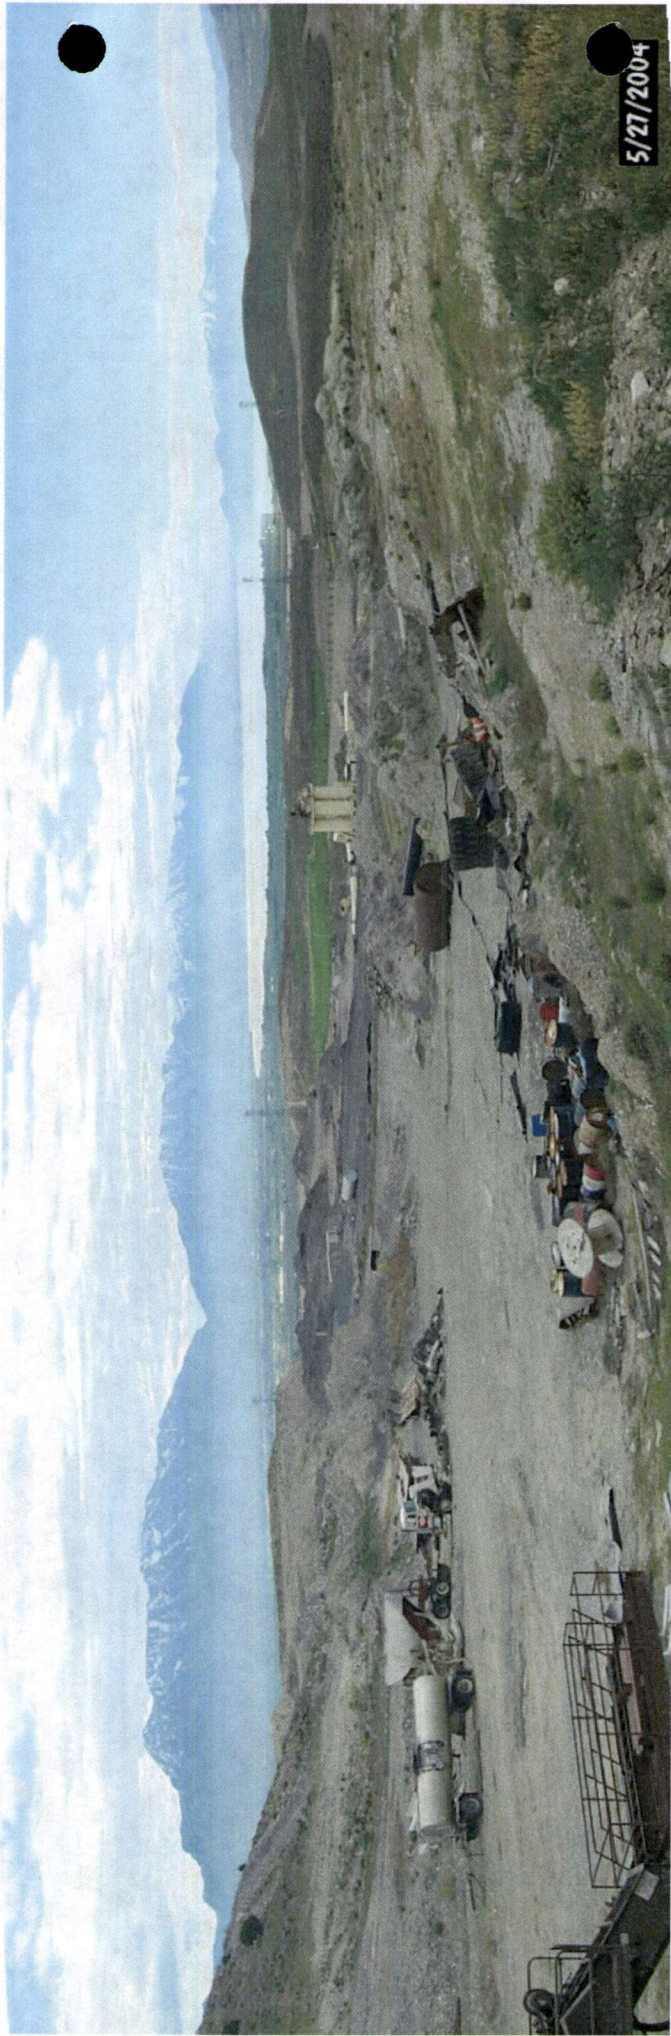
We toured the quarry site to review an area that was shown on their latest map as disturbed. This area was apparently disturbed in the early stages of the operation to provide material for a berm. The area has been revegetated and will not be considered a part of the permit area for bonding purposes. The berm created at the time is just above a laydown area (picture included), which was used by Western Aggregate (former operators) to store old and used equipment.

LAYDOWN AREA

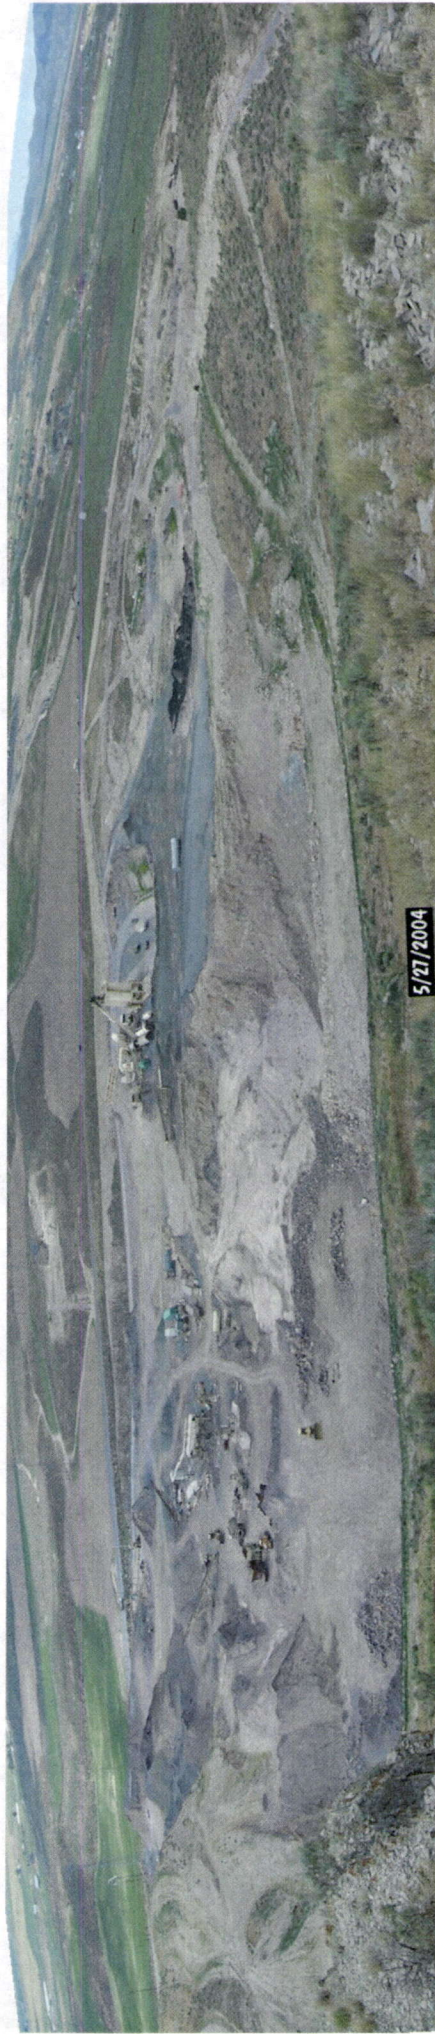
A photo showing the entire site was taken from a hill above the quarry.

PLANT OVERVIEW
